A.00 PREMISES IDENTIFICATION AND INSTRUCTIONS

Thattham Methodist Church
Bath Road
Thattham
Newbury
Berks
RG19 4RE

We are acting on written instructions received dated 1st August 2017 to carry out a Quinquennial Inspection on Thatcham Methodist Church, Thatcham.

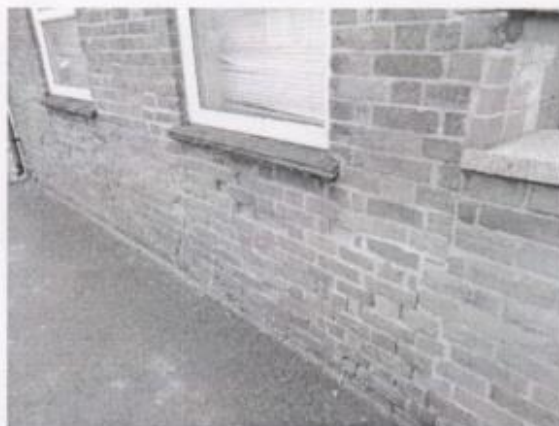
To the cottage the front elevation is in brickwork built in Flemish bond fashion having alternate headers and stretchers to each course. It is therefore of solid composition. Here there has been some re-pointing undertaken in a hard cement based mortar and this together with the fact that there has been salt water splashback from the road has

caused delamination to the face brickwork in a number of areas. Any bricks which have suffered in this manner should be taken out and replaced.

Spalling to face brickwork

Replace bricks which have spalled and lost their facings.

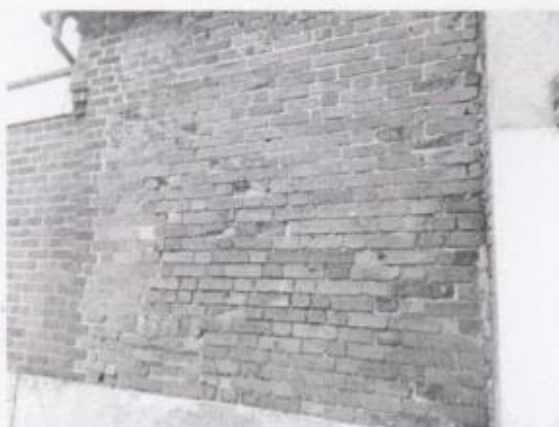
The west flank elevation is finished mainly with a rendered face, although part brickwork towards the north. I noted that many of the bricks on the north side have been re-faced in a hard cement mortar. This should not be considered as a long term repair and bricks which have been re-faced in this manner should be taken out and replaced. Also any which have delaminated should be similarly treated.

Delaminated and refaced bricks.

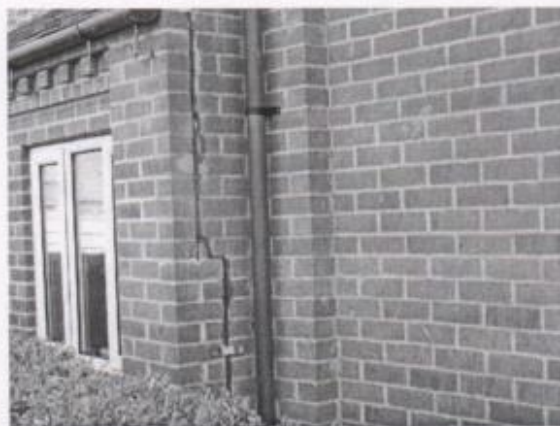
There is a tall vertical crack in the projecting corner on the west side of the office externally. There is a long length of brickwork along this elevation and I believe that this crack is associated with thermal rather than structural movement. I suggest that it should be filled with a flexible mastic as movement will obviously continue throughout the life of the building. Filling the crack will help to keep rainwater ingress at bay.

Vertical crack

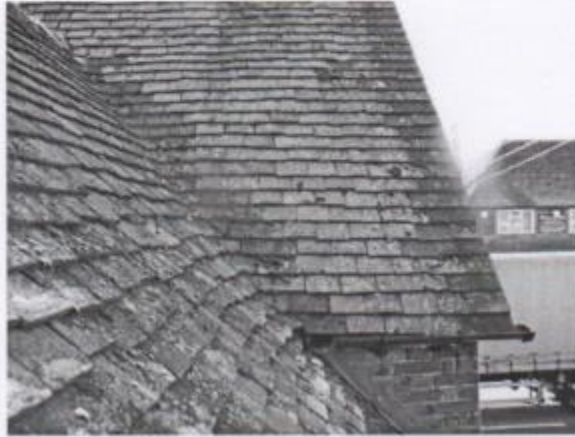
Over the original cottage the roof is twin pitched and is covered with plain clay tiles with half round ridge tiles to the apex. There is a tiled valley at the intersection. The roof is slightly uneven, but the fact that there is underlay sarking present suggests that it has been re-covered within recent times. There is unevenness also in the tiling itself which suggests that the supporting battens have deflected.

Uneven tiles

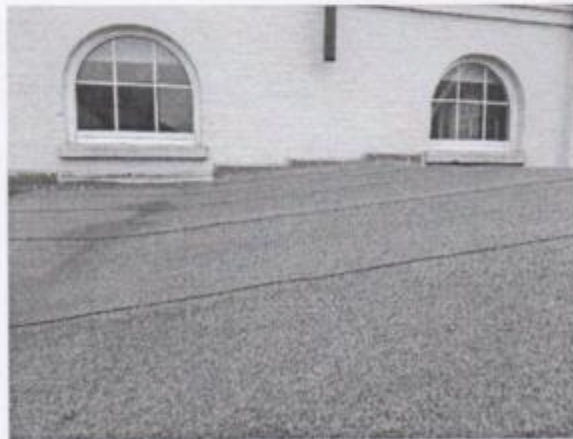
The central link between the cottage and the church is in built up felt. There are no stone chippings nor solar reflective paint to the surface. There is no lead cover flashing to the upturn to the walls to each end. Leadwork is used below the windows to the church but is torn here. The roof surface is probably some 10 years old and as such I would anticipate that within the next 5 years repairs will be necessary and possible renewal as felt roofs of this type are known to have limited lives of some 15 years from new. At the time of renewal, the insulation values as well as the need for ventilation should be examined and upgraded as necessary.

Felt roof

Budget to replace felt roof area.

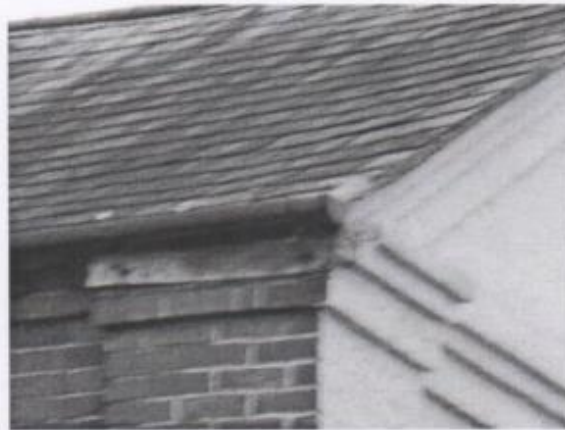
The rear roofs are also twin pitched and covered with natural slate with half round ridge tiles to the apex. Some tingles have been used to reinstate slates which have slipped in the past. However, there are not a sufficient number of these slates to suggest the roof has become nail sick. At least one slate to the West slope has slipped out of position. There are some damaged slates on the West side of the intermediate single storey structure close to the eaves and these should be reinstated.

Tingles to slate roof

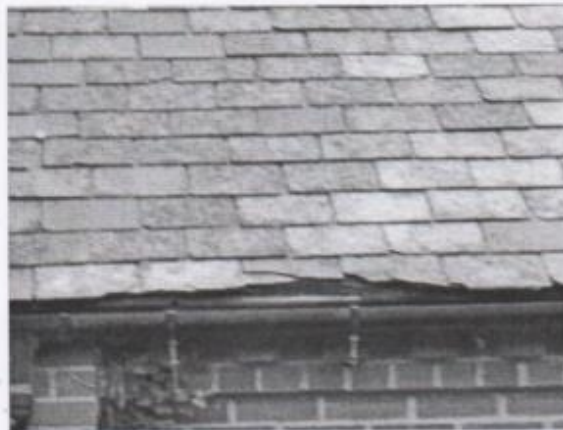
Damaged Slates

Any slates which slip out of position should be reinstated

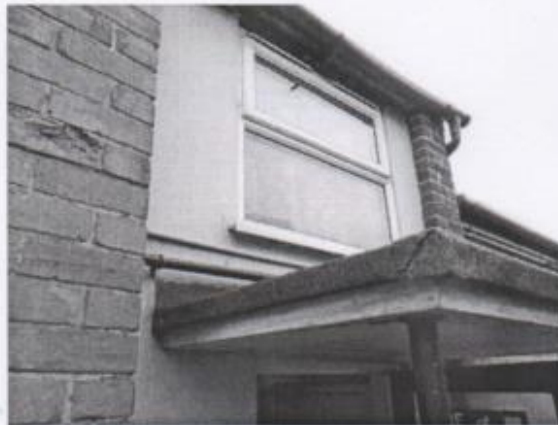
Windows are mainly UPVC framed and double glazed. There is still one window over the porch which is suffering from defective seals and this should be replaced.

Misting to glazed leaf

Replace double glazed windows which are suffering from defective seals.

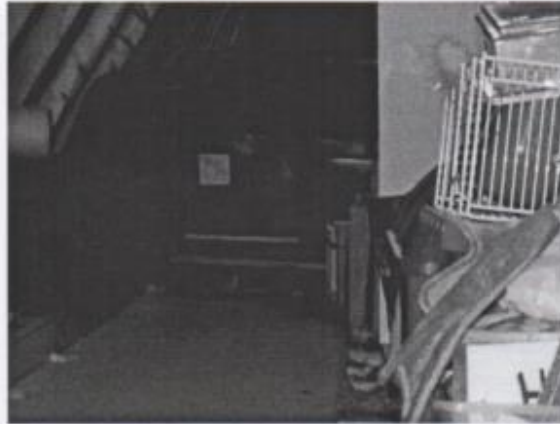
The two domestic cold water storage tanks have now been replaced but are not taken on the node points in the truss formation as is recommended. This could lead to disproportionate collapse.

Incorrectly supported tanks

The water storage tanks are new in the loft area as previously described. These should be properly insulated and covered. Ideally they should be positioned on supporting beams close to the node points in the truss formation.
